Inspection Report

Minerals Regulatory Program

Mine Name: Beck Street Quarry	Permit Number: M/035/0020
Operator Name: Lakeview Rock Products, Inc.	Inspection Date: September 30, 2009
Inspector(s): L Heppler	Time: 4:00 PM
Other Participants: Operator Representative – John Burgraff	Mine Status: Active

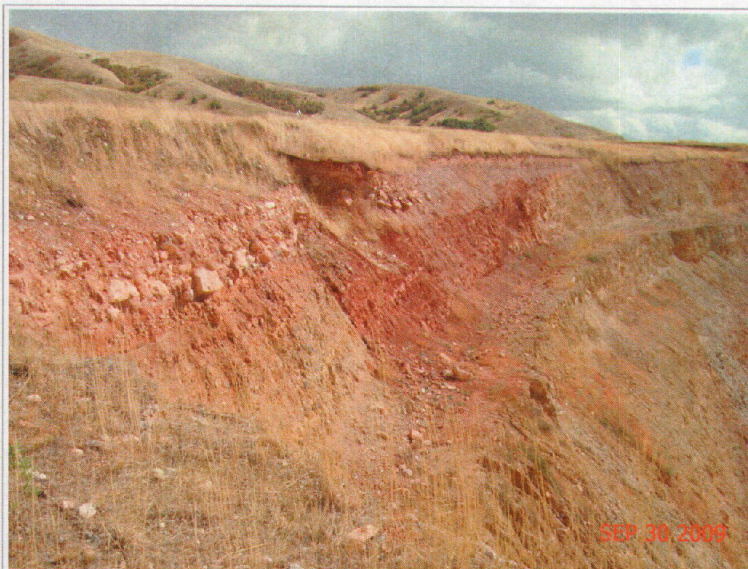
Overview of upper mine site – looking south

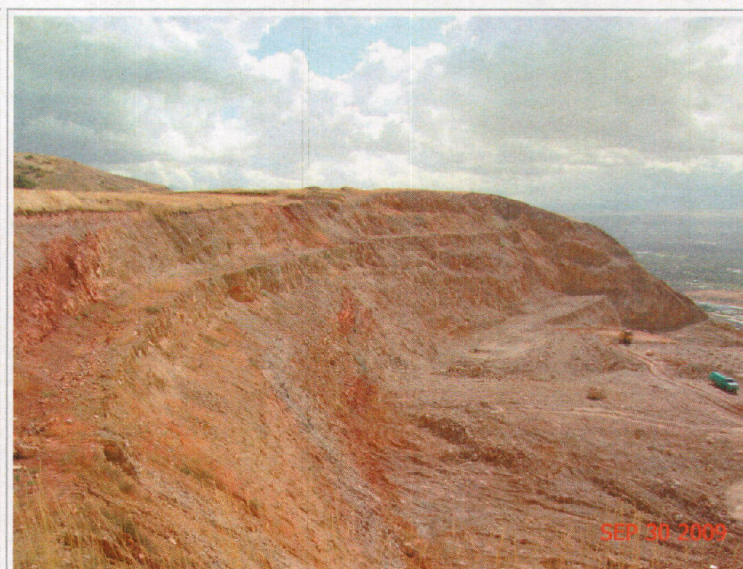
Overview of upper mine site – looking south

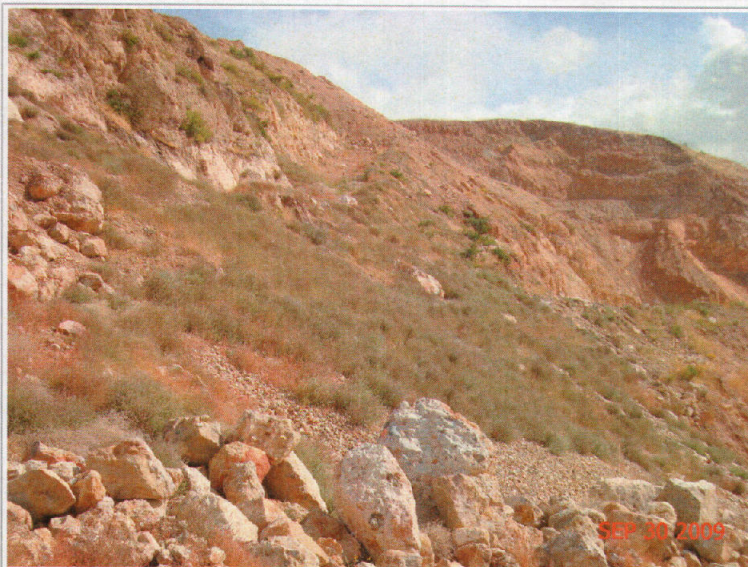
Inspection Summary: NOI on file with the Division. Overall the Operation is well maintained - no erosional problems were noted, fence was maintained, no deleterious material was noted and roads were in good condition. Laydown storage was on edges of haul roads. Russian thistle was noted throughout the site. Every effort should be made to salvage top soil from the site prior to mining. There is a pending request for bond release by the Operator submitted on October 12, 2012.

Below upper mine site – looking south – note Russian Thistle

Conclusions and Recommendations: Operator is past due for a periodic plan review, which includes a bond escalation review. The operator should make an effort to control weeds before they invade the mine site. OGM to continue annual inspections and monitor the site when in the area.

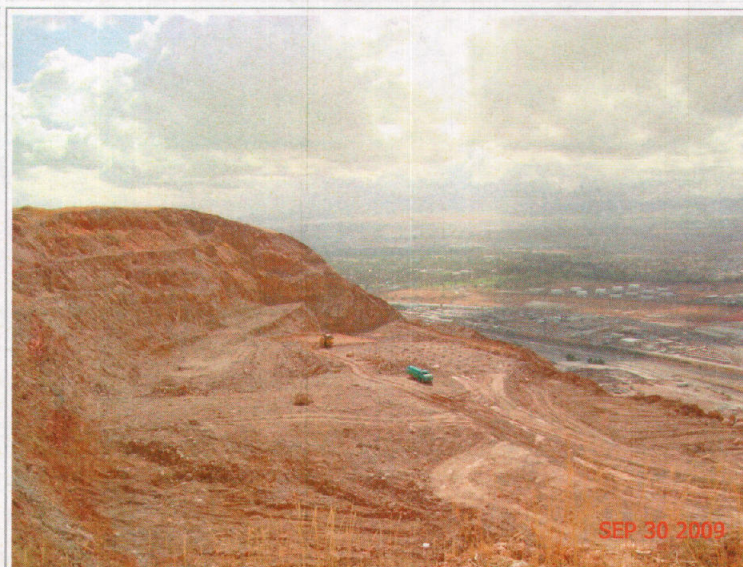
Overview of upper mine site – looking south – Blast pattern

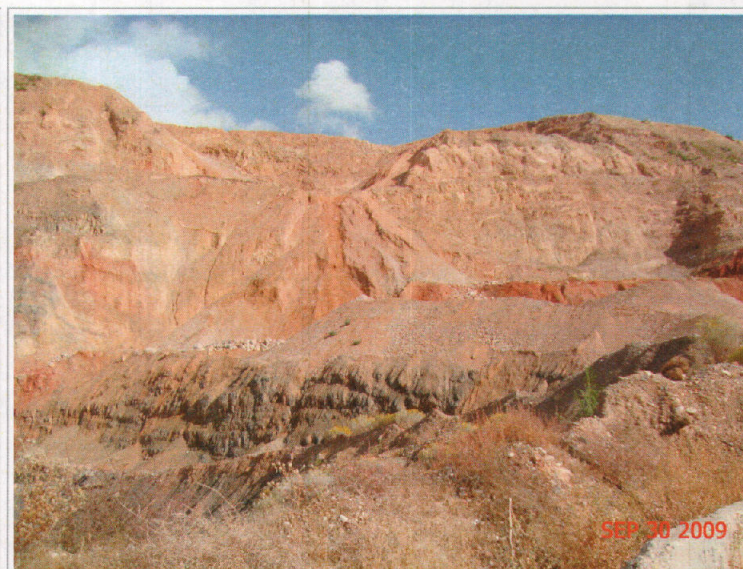
Lower pit – note dozer slot, from upper pit

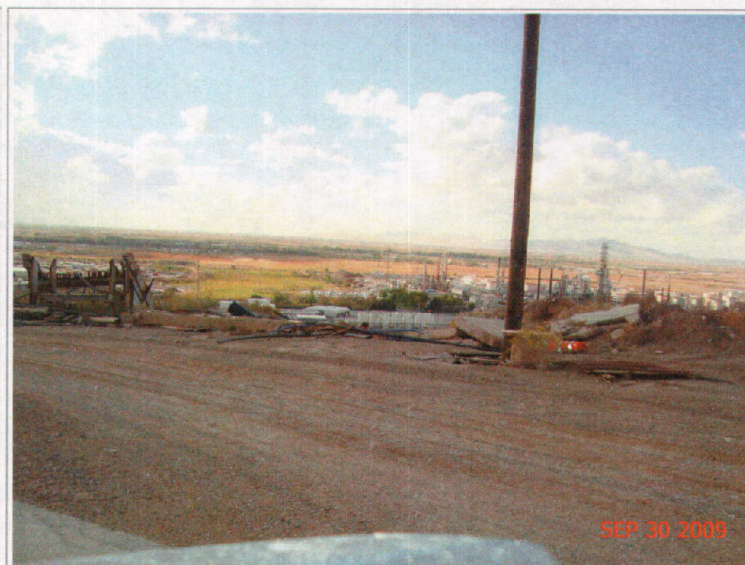
Storage along haul road

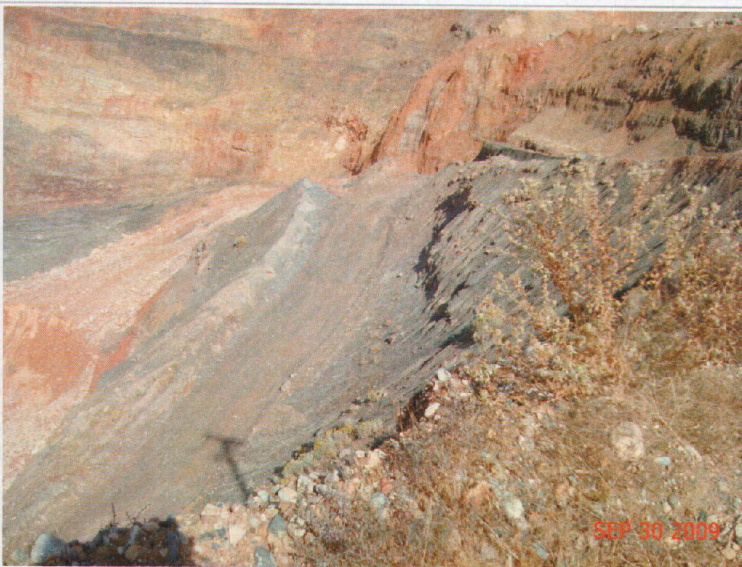
Haul road on south side of lowr pit
